HO-1033
Henry Lotz Farm
5910 Waterloo Road
Private

Historic Properties Form

Inventory No. HO-1033

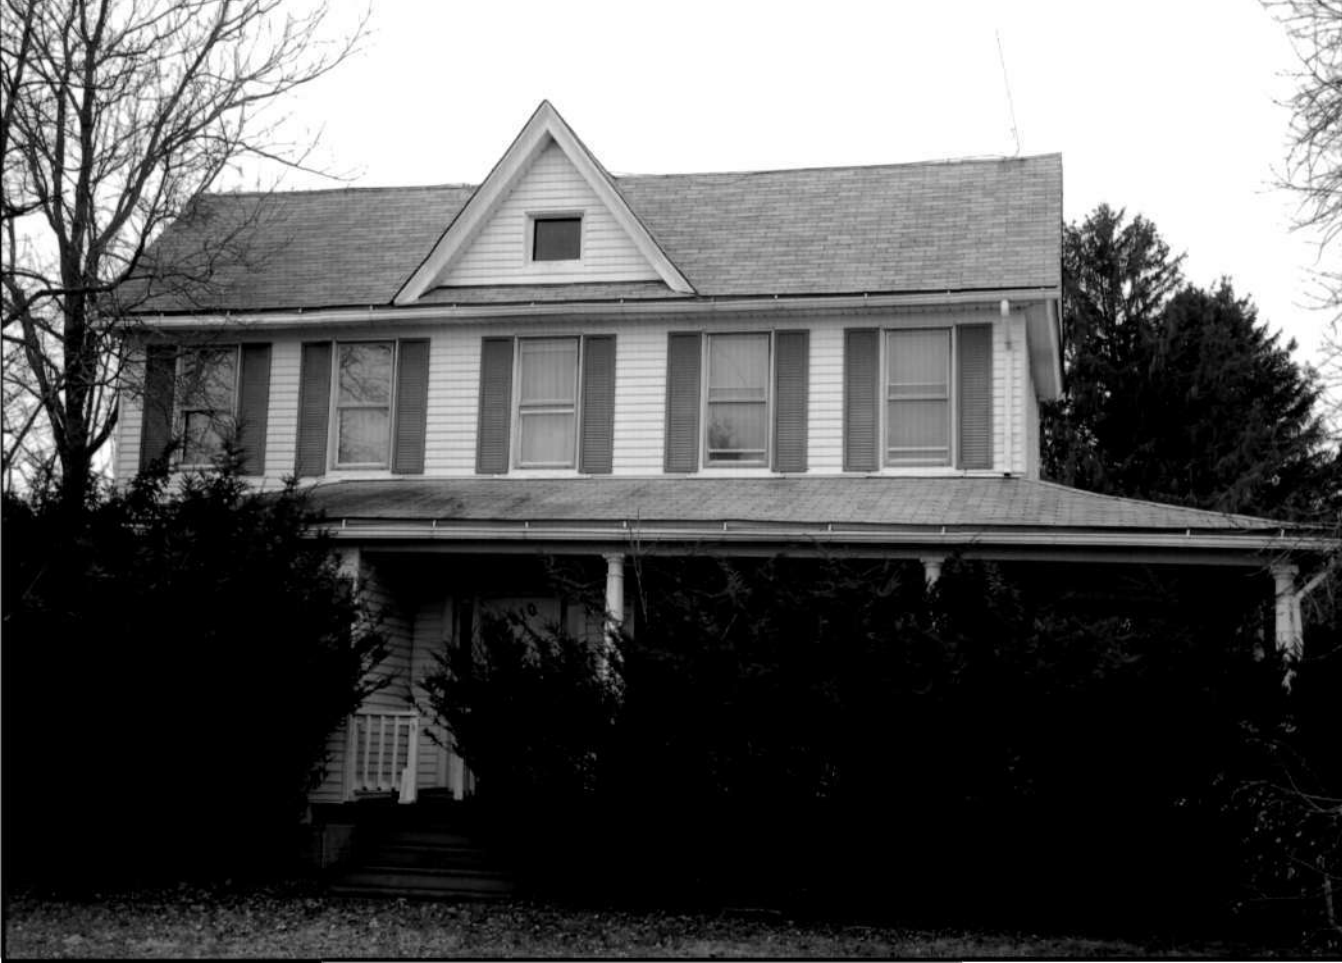
1 of 8

House, northeast elevation

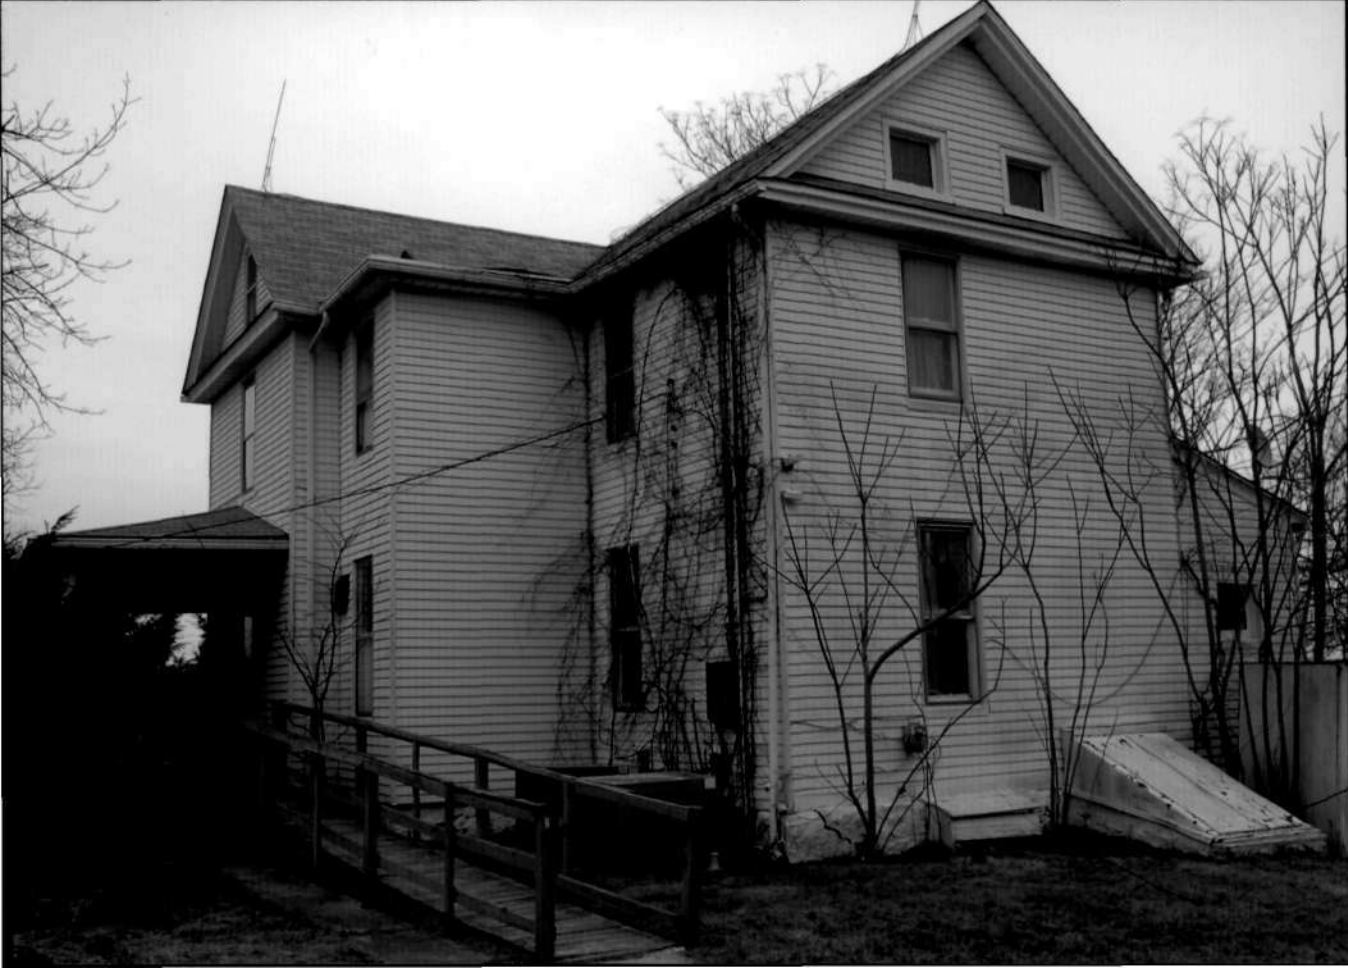
2 of 8

House, northwest + southwest elevations

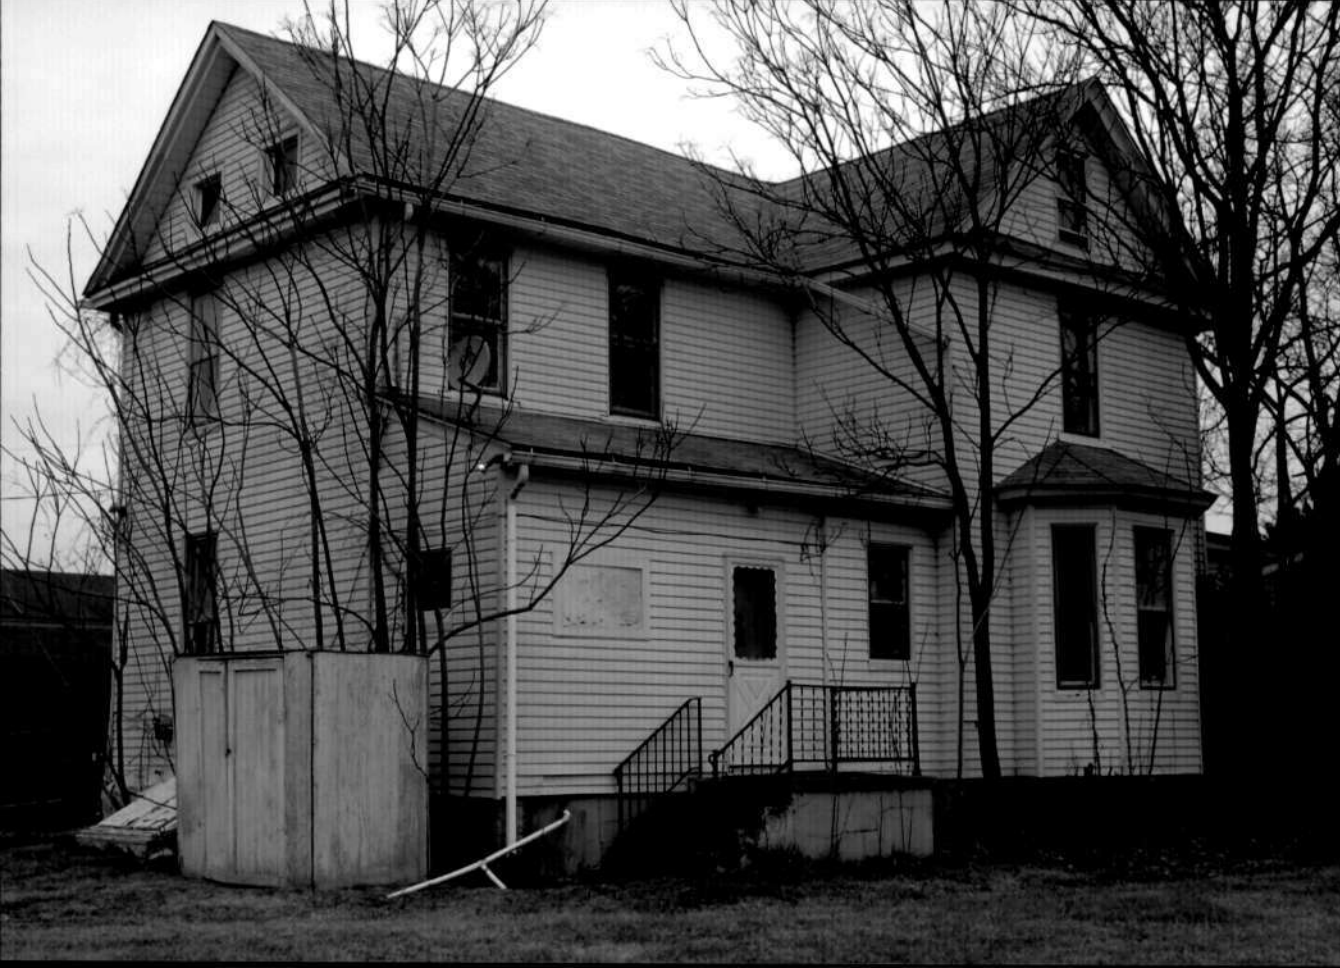
3 of 8

House, southwest + southeast elevations

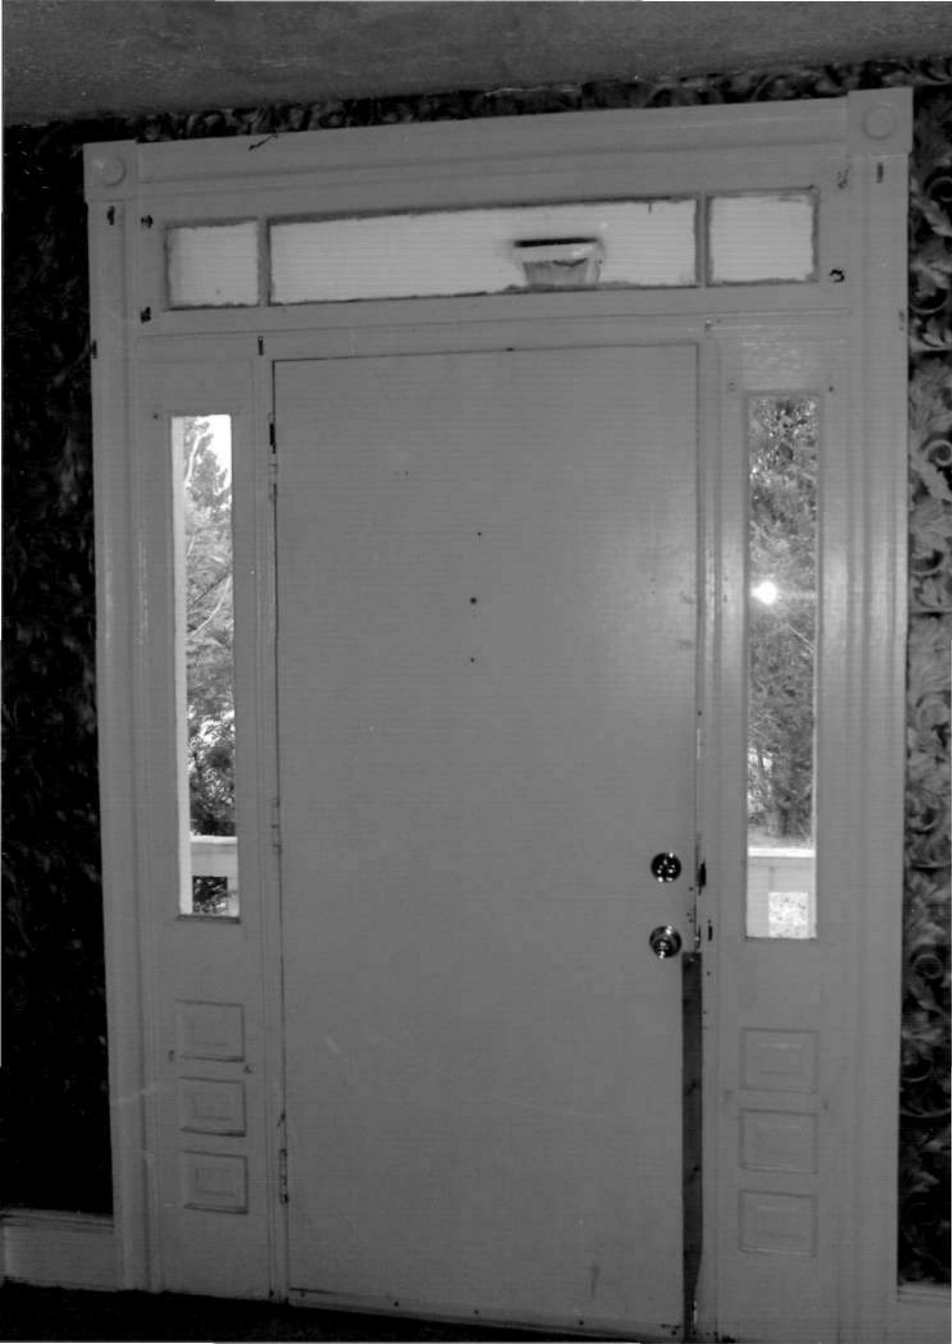
4 of 8

House, interior, front doorway

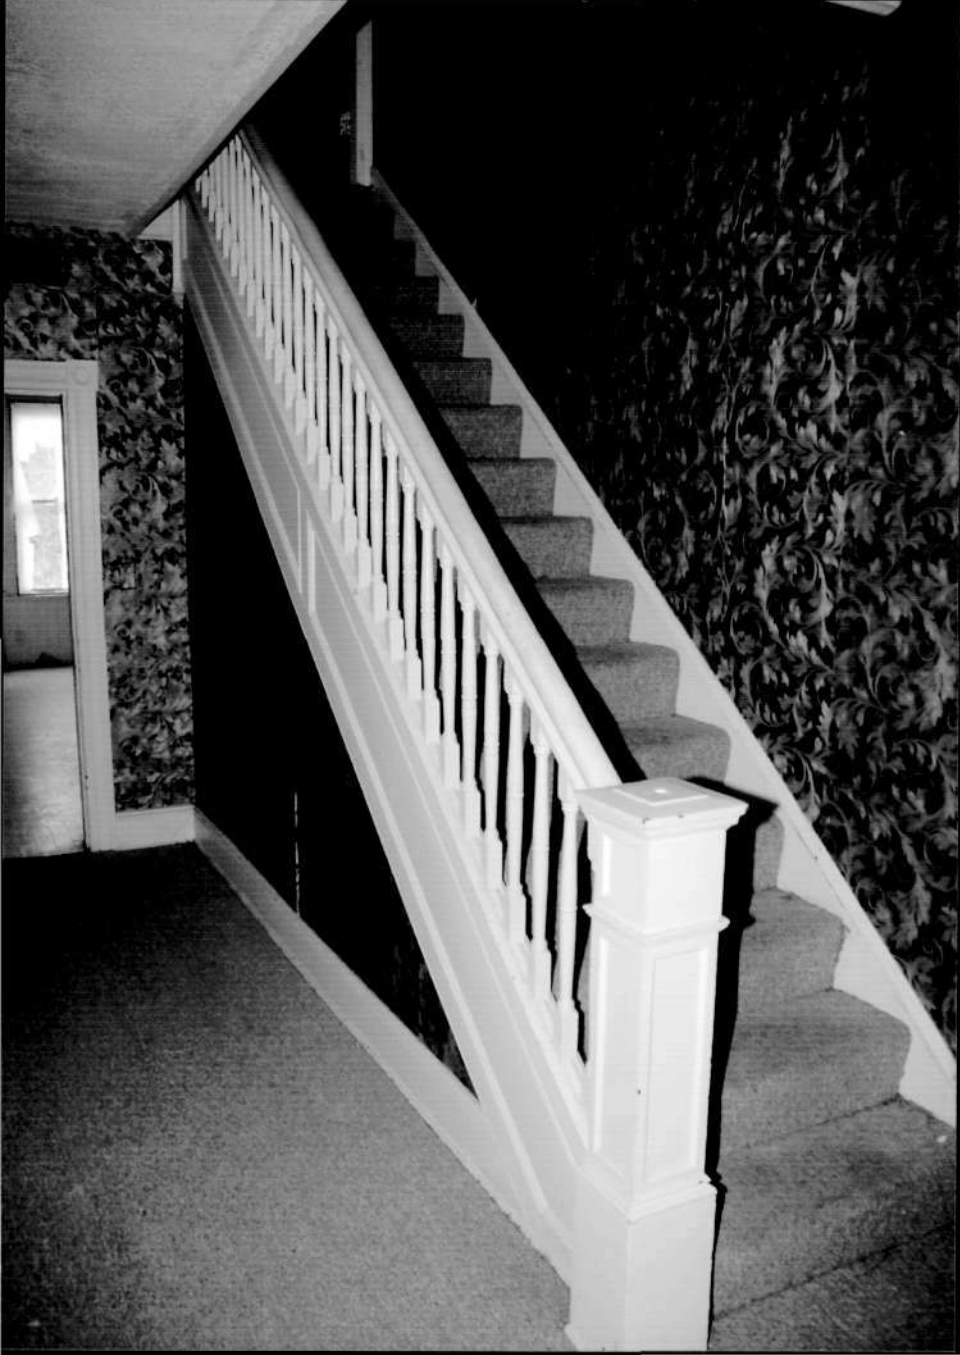
5 of 8

House, interior, passage, vw. west

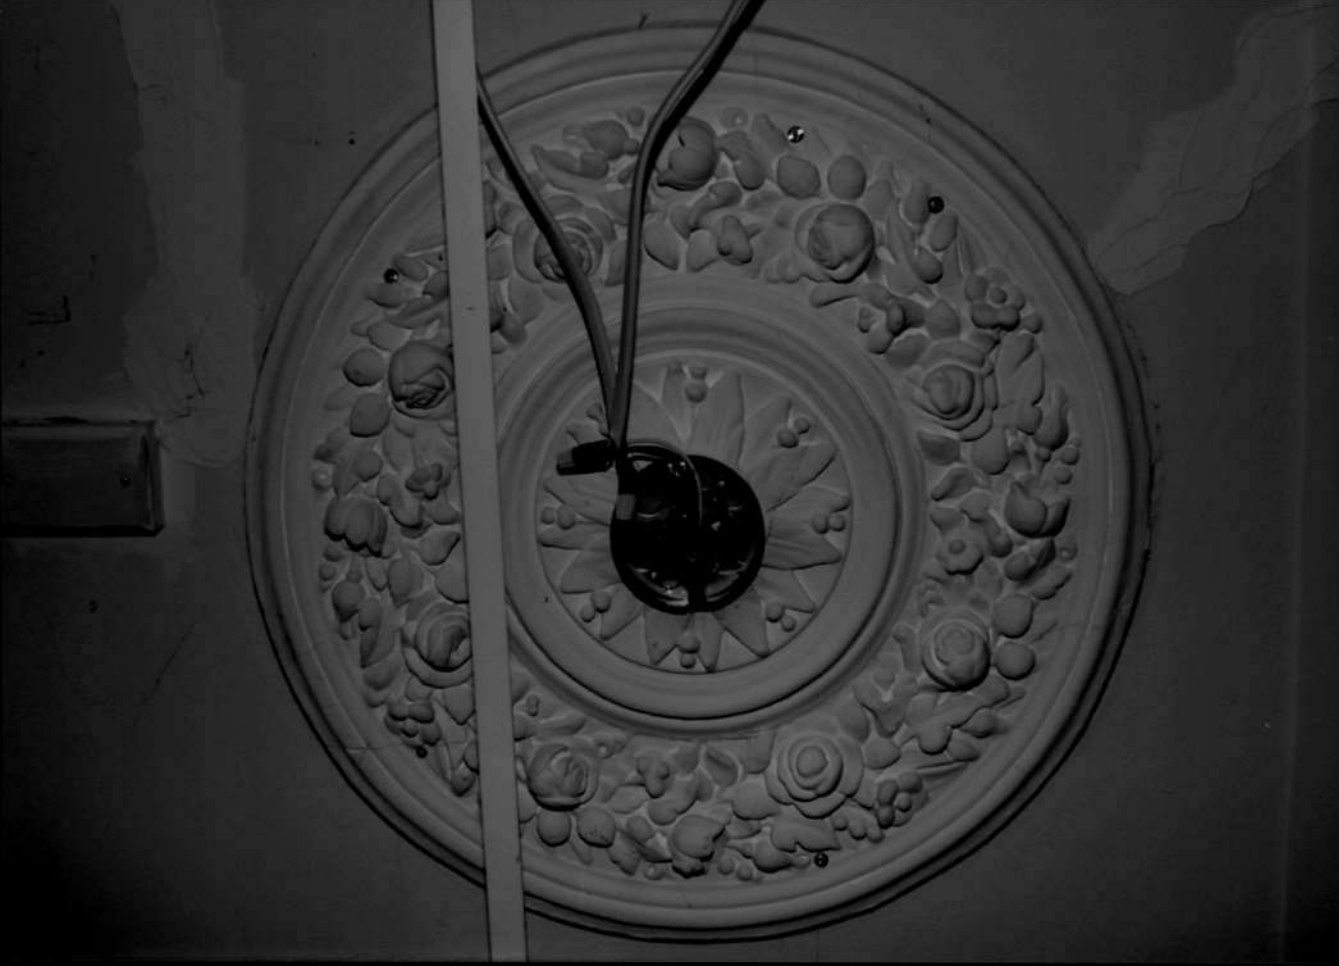
6 of 8

House, interior, north room ceiling
medallion

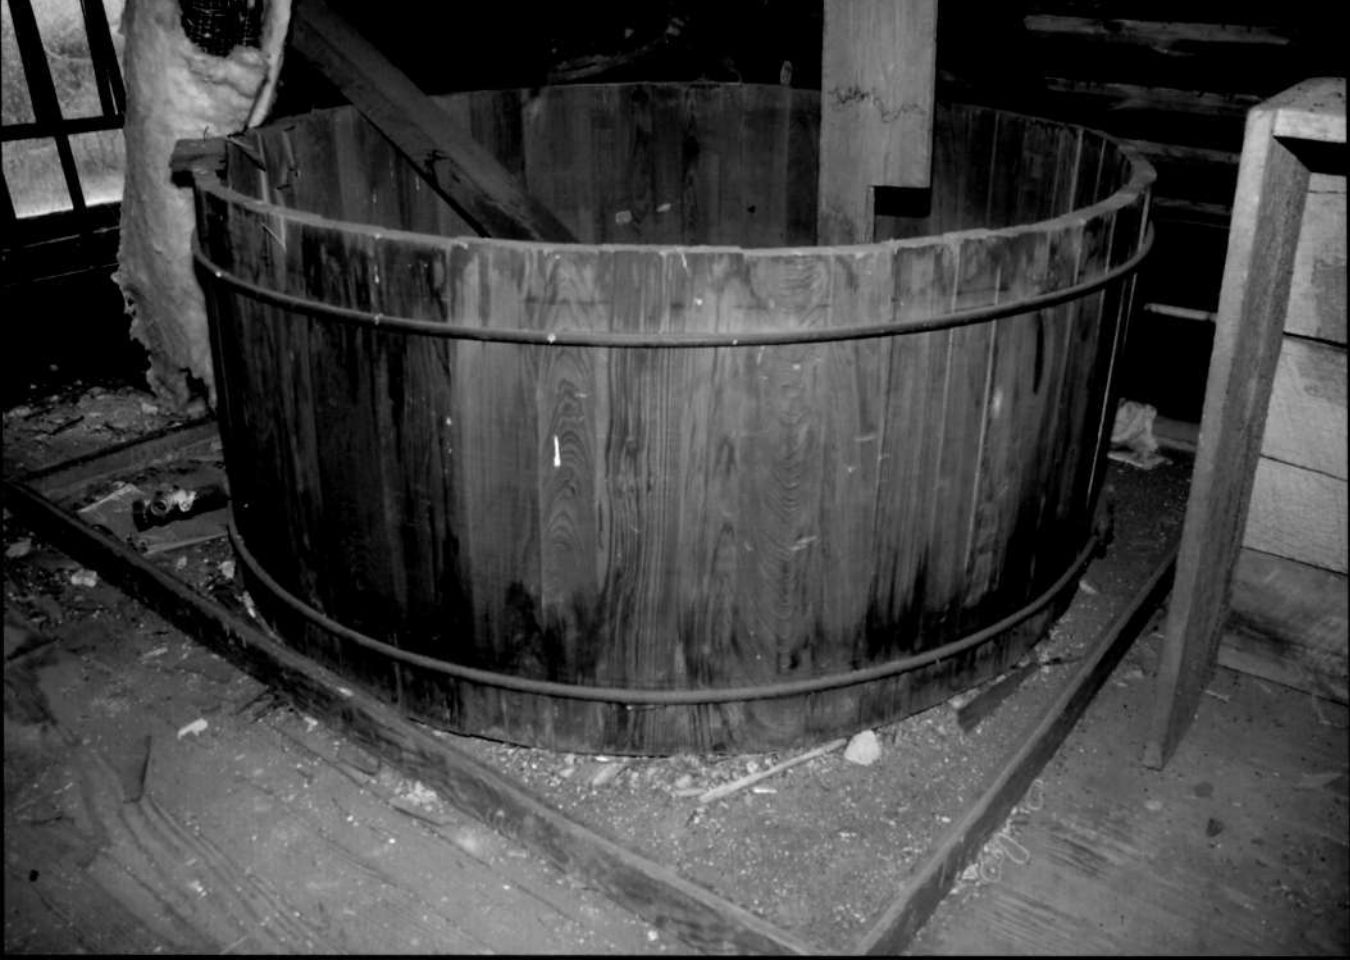
7 of 8

There is a wood cistern in the ell, set in a tray with a galvanized metal lining. There is a pipe at the bottom of this cistern, on the south side of it, and this pipe has a "T" on it. There is also a hole at the top of the northwest side of the cistern, probably for overflow. The cistern is not labeled. The bottom boards of the cistern are doveled together, and are otherwise flush and butted. The bottom boards are narrowed on the ends to fit into rabbets near the bottom of the side staves, and these staves are butted against each other. The bottom side of the bottom boards is black, and this appears to be paint. The galvanized metal tray sits loosely on the floor, with several boards fitting in the tray, and the cistern sat on these loose boards. The sides of the tray are turned up and over pieces of wood that are nailed to the floor with cut nails. One of the cistern staves has a copper plaque nailed to it, and the plaque is embossed with "The Baltimore Cooperage Company Tank & Tower Builders Baltimore, MD." Another stave has four small nails in it, and two of the nails appear to have held a thin wood or heavy cardboard item that may have been a shipping label, and the other two nails held some kind of metal tag. All four nails are near each other, so this could have been one larger tag, but whatever it was, it is missing.

House, interior, cistern
